6616-73  
RI 9499

REPORT OF INVESTIGATIONS/1994

## Self-Contained Self-Rescuer Field Evaluation: Fourth-Phase Results

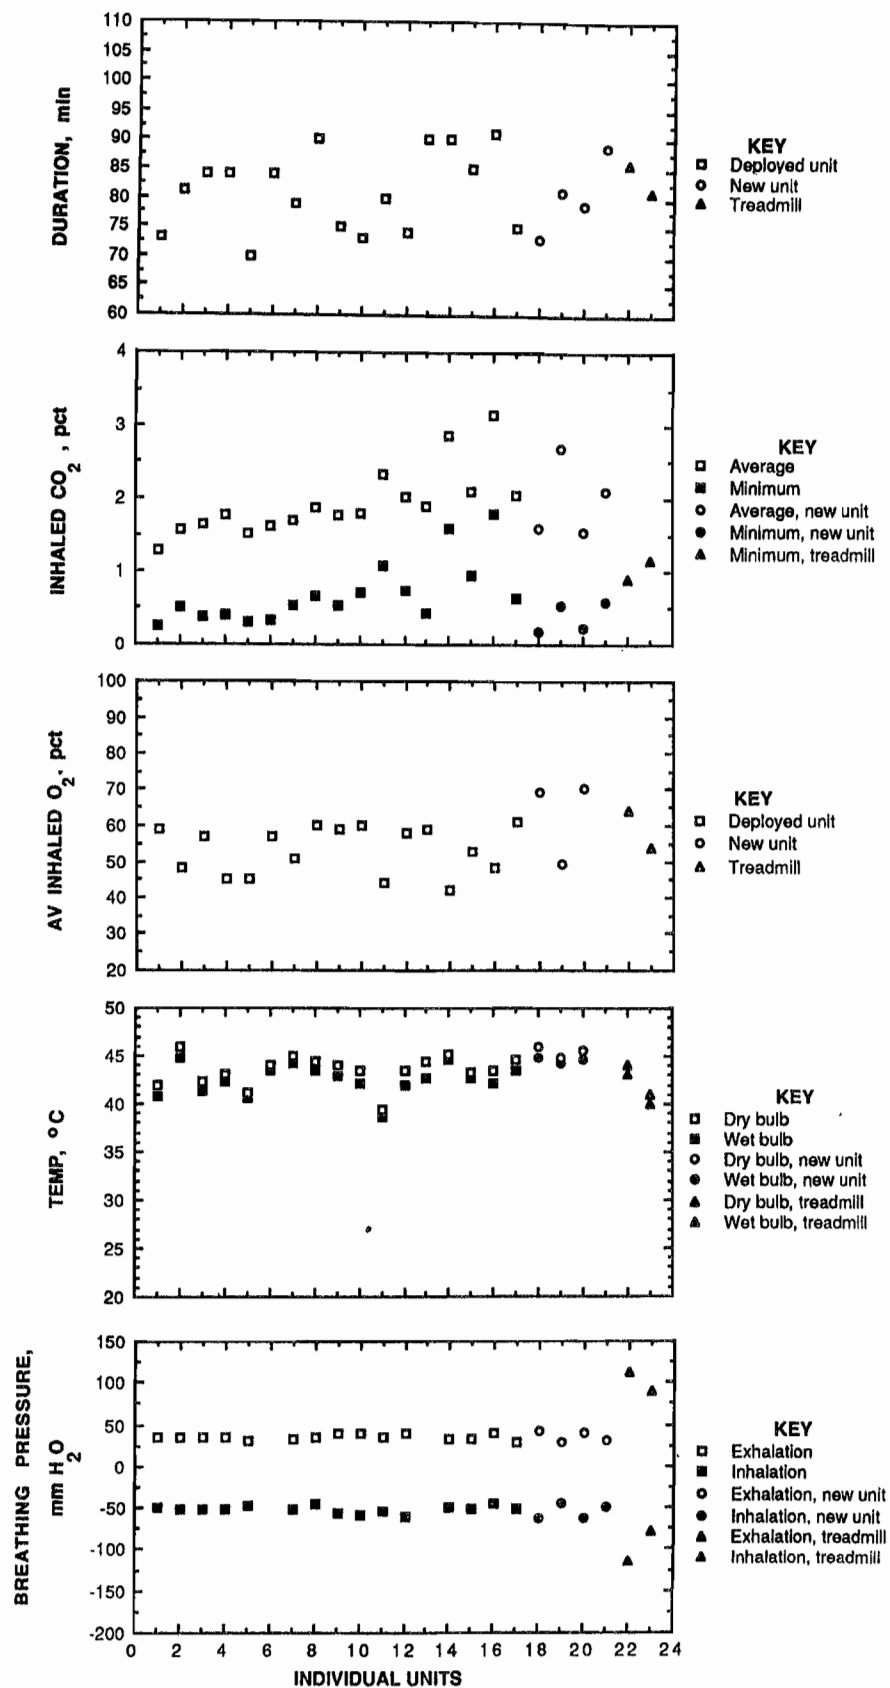
Figure 1.—CSE units.

Experience with each brand of apparatus is discussed separately. The values of the monitored parameters were averaged over the entire test duration and are presented graphically (figs. 1-4) for each apparatus by parameter. The values for deployed units tested on the BMS can be compared with the values for new units tested on the BMS, and to some extent, with deployed units tested on human subjects on a treadmill, which are plotted afterward. Because human subjects may differ from each other and from the BMS in terms of  $\dot{V}CO_2$ ,  $\dot{V}_e$ , and respiratory frequency, all of which will affect apparatus duration as well as all of the monitored parameters, these tests cannot be considered necessarily equivalent to the BMS tests even though the O<sub>2</sub> consumption rate is the same. Missing data points are indicative of equipment malfunction or other anomaly that invalidated the data.

The Wilcoxon rank-sum tests for the wet- and dry-bulb temperatures showed higher values for new than deployed units. As can be seen from figure 1, however, the new-unit values are only slightly higher than the deployed values; if deployment causes the apparatus to run cooler, that is no cause for alarm. It has been found that the temperature of the laboratory and the use of the exhaust fan significantly affect the inhalation temperature of the apparatus being tested. The higher new-unit temperatures may be attributed to coincidentally high laboratory temperatures. Real or coincidental, the finding is of little concern for this study.
